NONDESTRUCTIVE EVALUATION OF DAMAGE
IN METAL MATRIX COMPOSITES

David A. Ulman, Edmund G. Henneke, John C. Duke,
Kenneth L. Reifsnider and Wayne W. Stinchcomb

Final Report
June 1, 1980

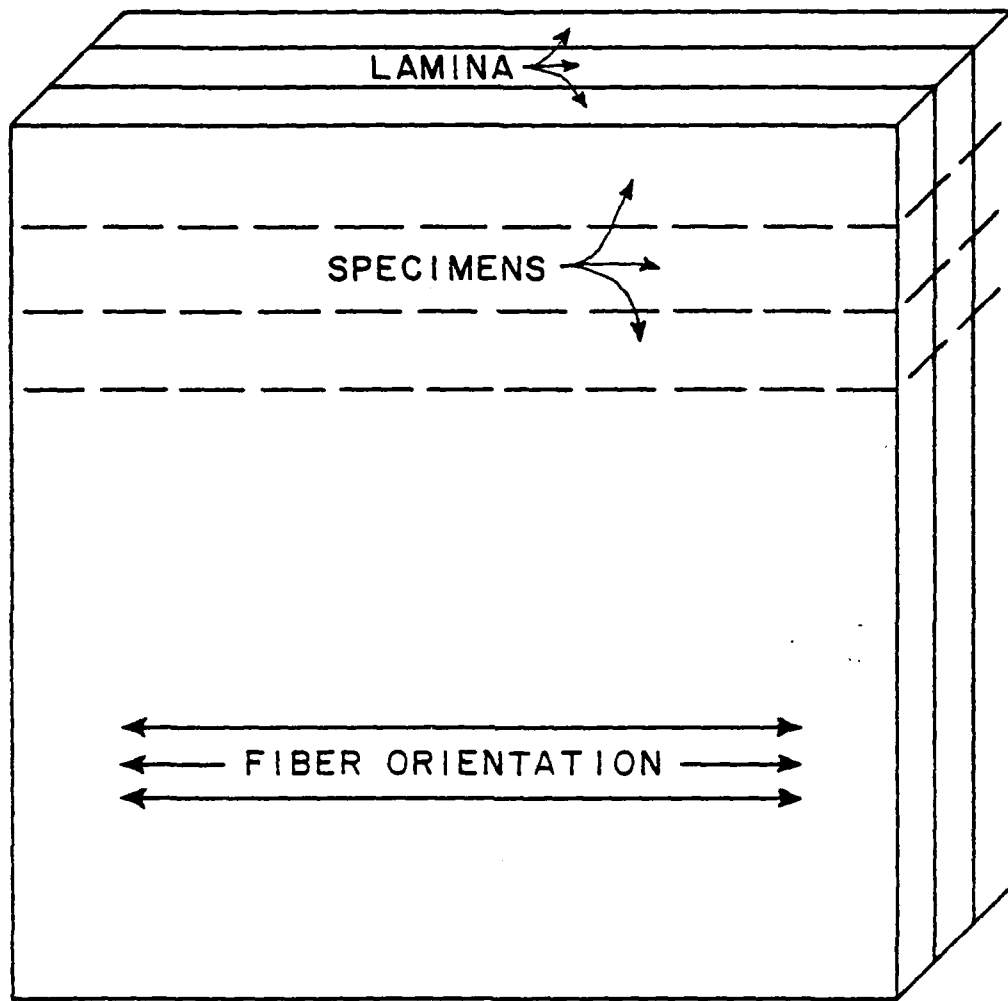
Figure 1: Specimens are sliced perpendicular to the lamina and parallel to the fibers.

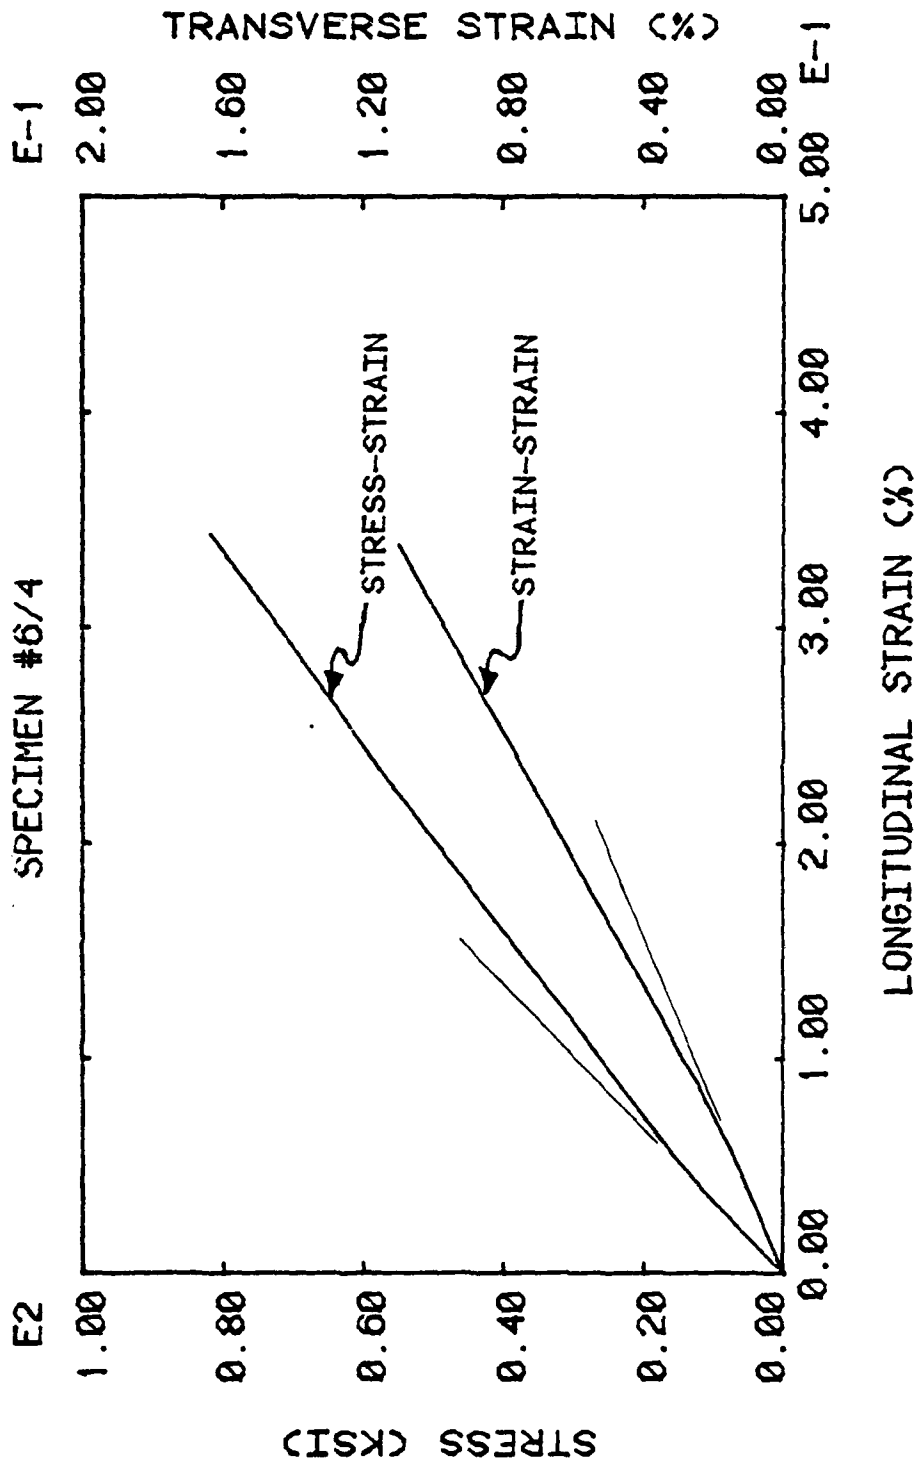
Figure 7: Stress and Transverse Strain versus Longitudinal Strain for Tension Test.

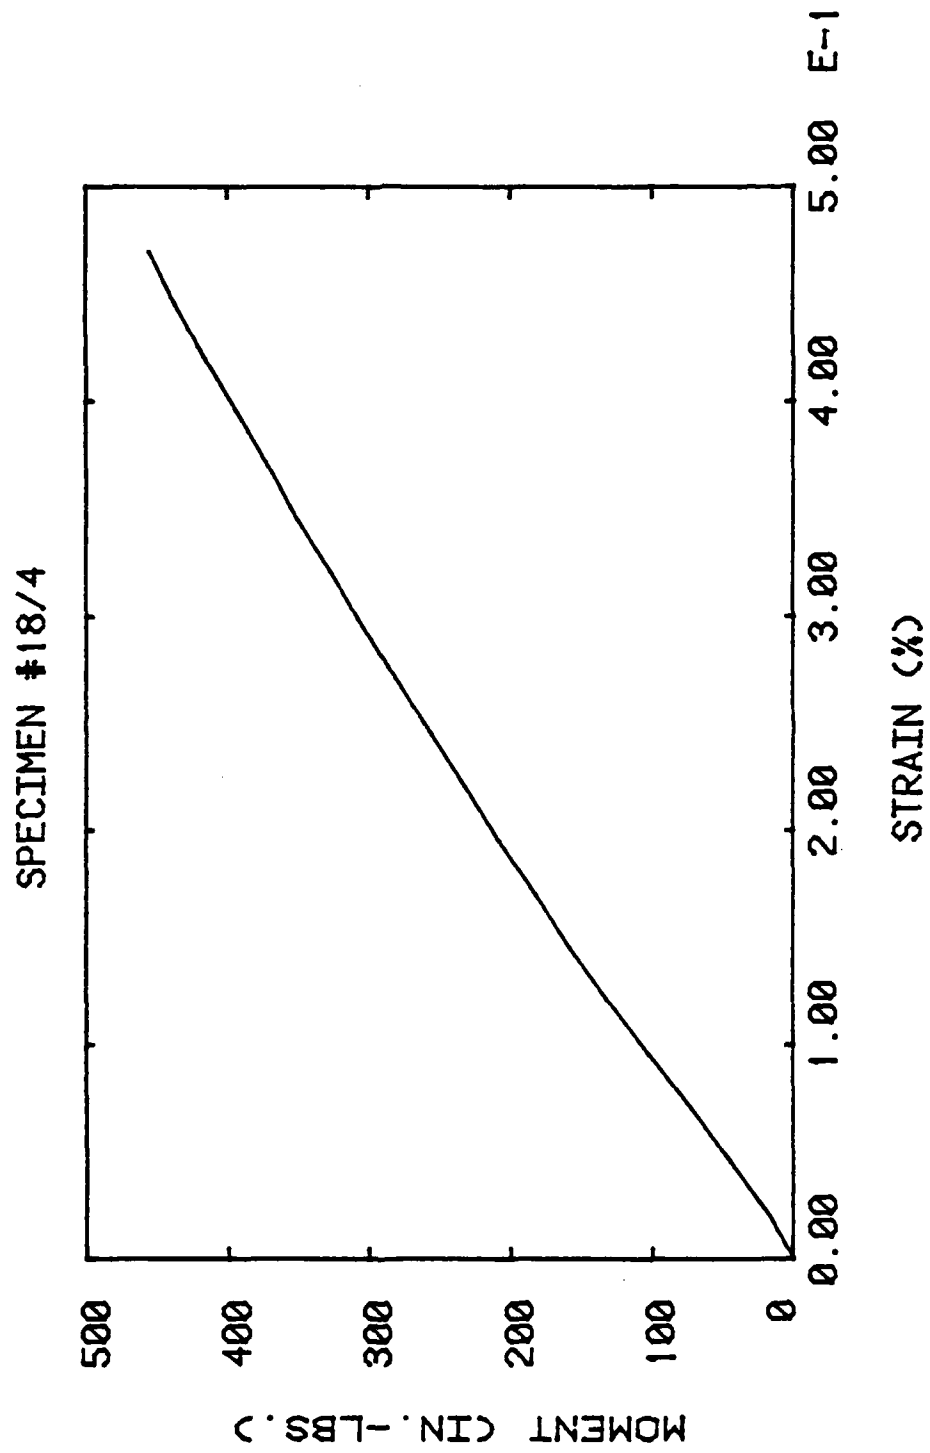
Figure 8: Maximum Moment versus Strain during Bend Test

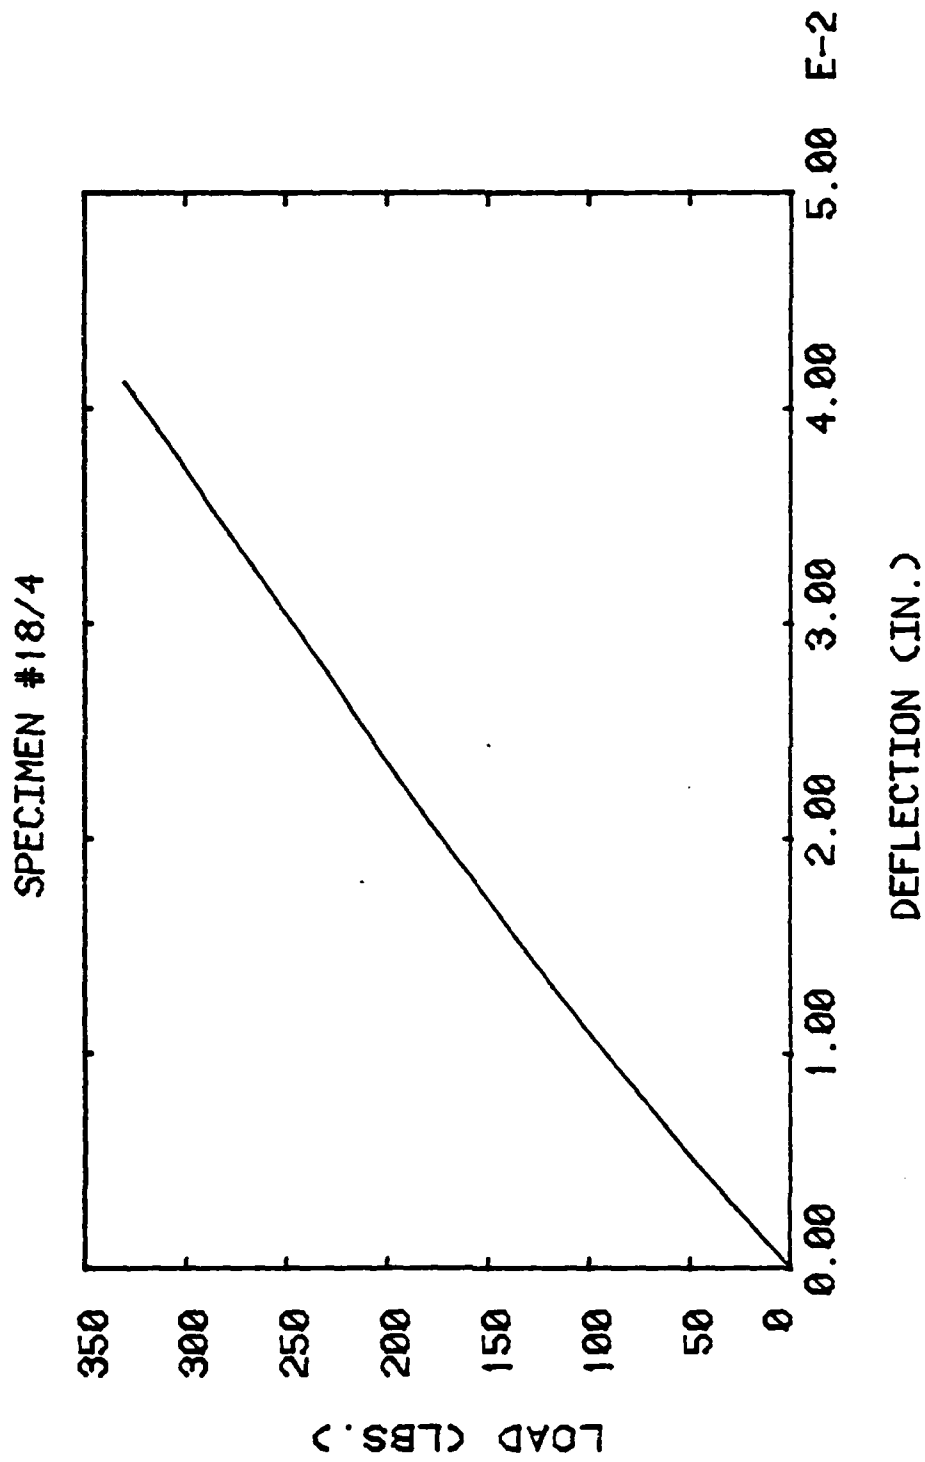
Figure 9: Load versus Deflection for Bend Test.

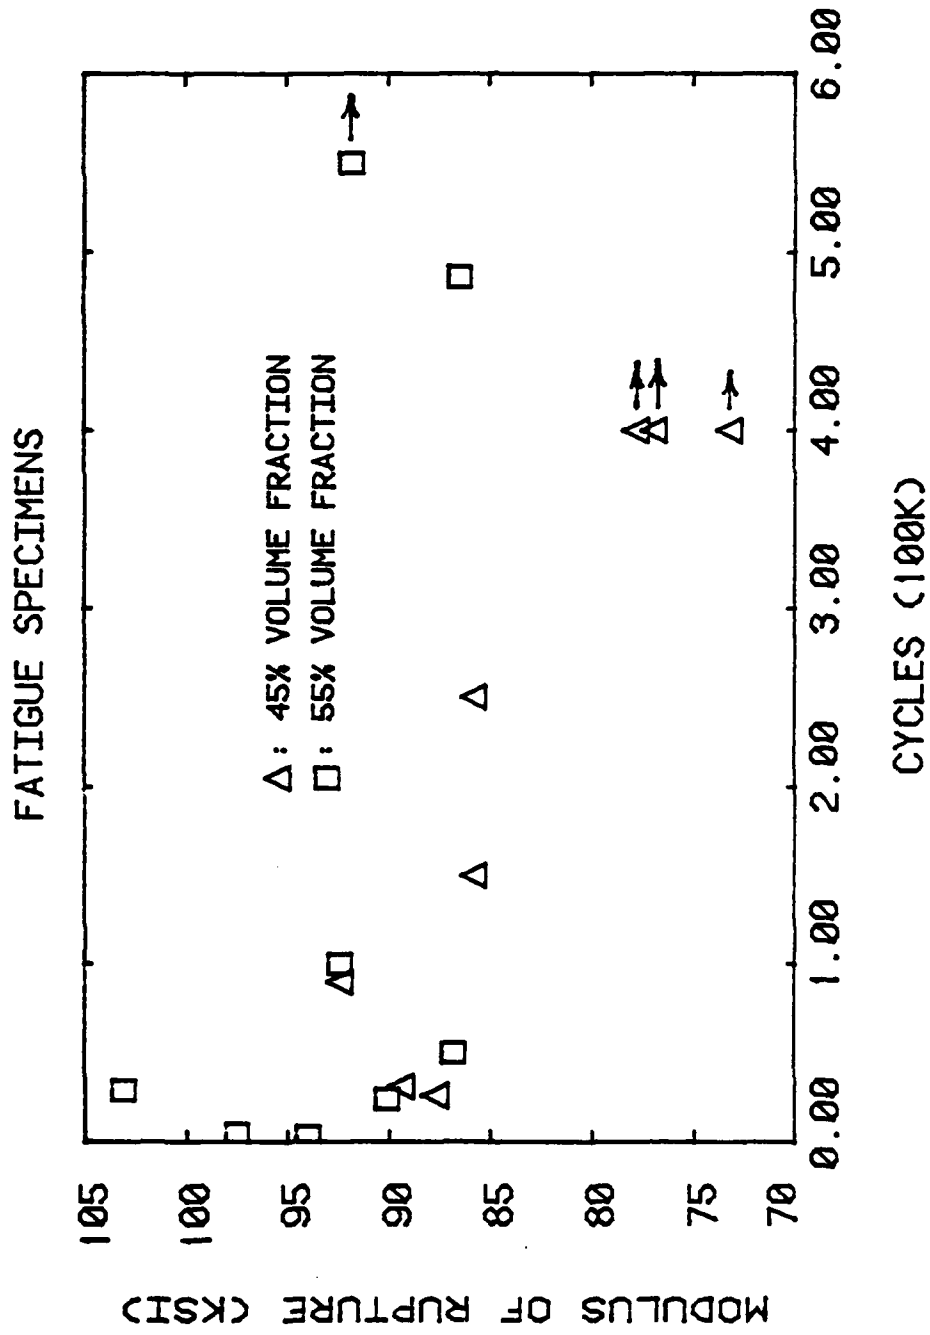
Figure 10: Modulus of Rupture versus the Number of Cycles to Failure.

substantially weakened. The point farthest to the right is specimen 16/5 which failed after 1028K cycles at a maximum fatigue load of 240 pounds.

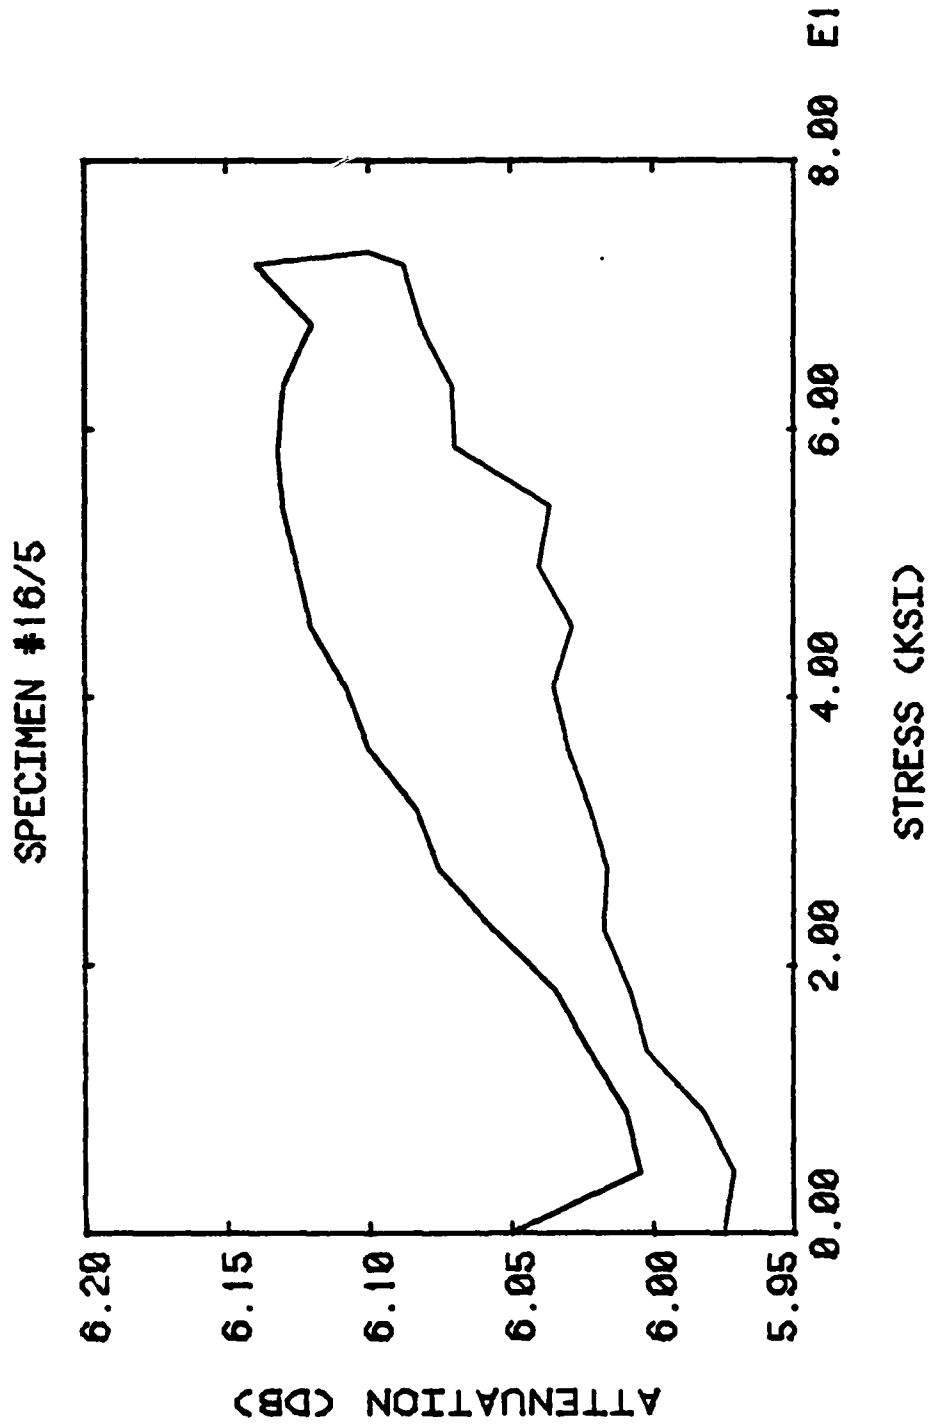
Figure 19: Ultrasonic Attenuation measured during Quasi-Static Tension Test.

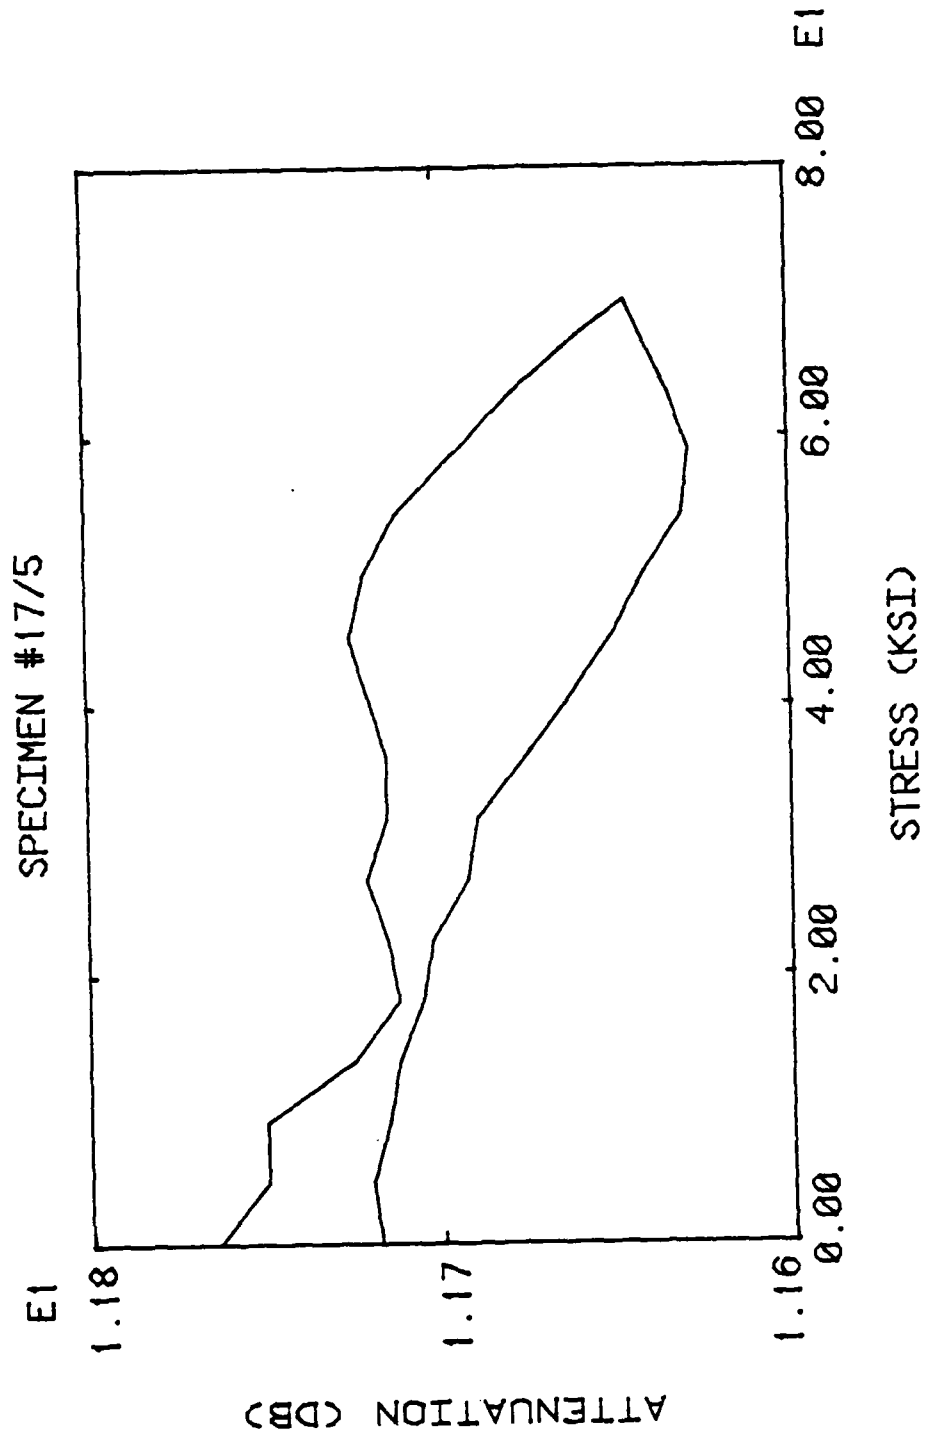
Figure 20: Ultrasonic Attenuation measured during Quasi-Static Tension Test.

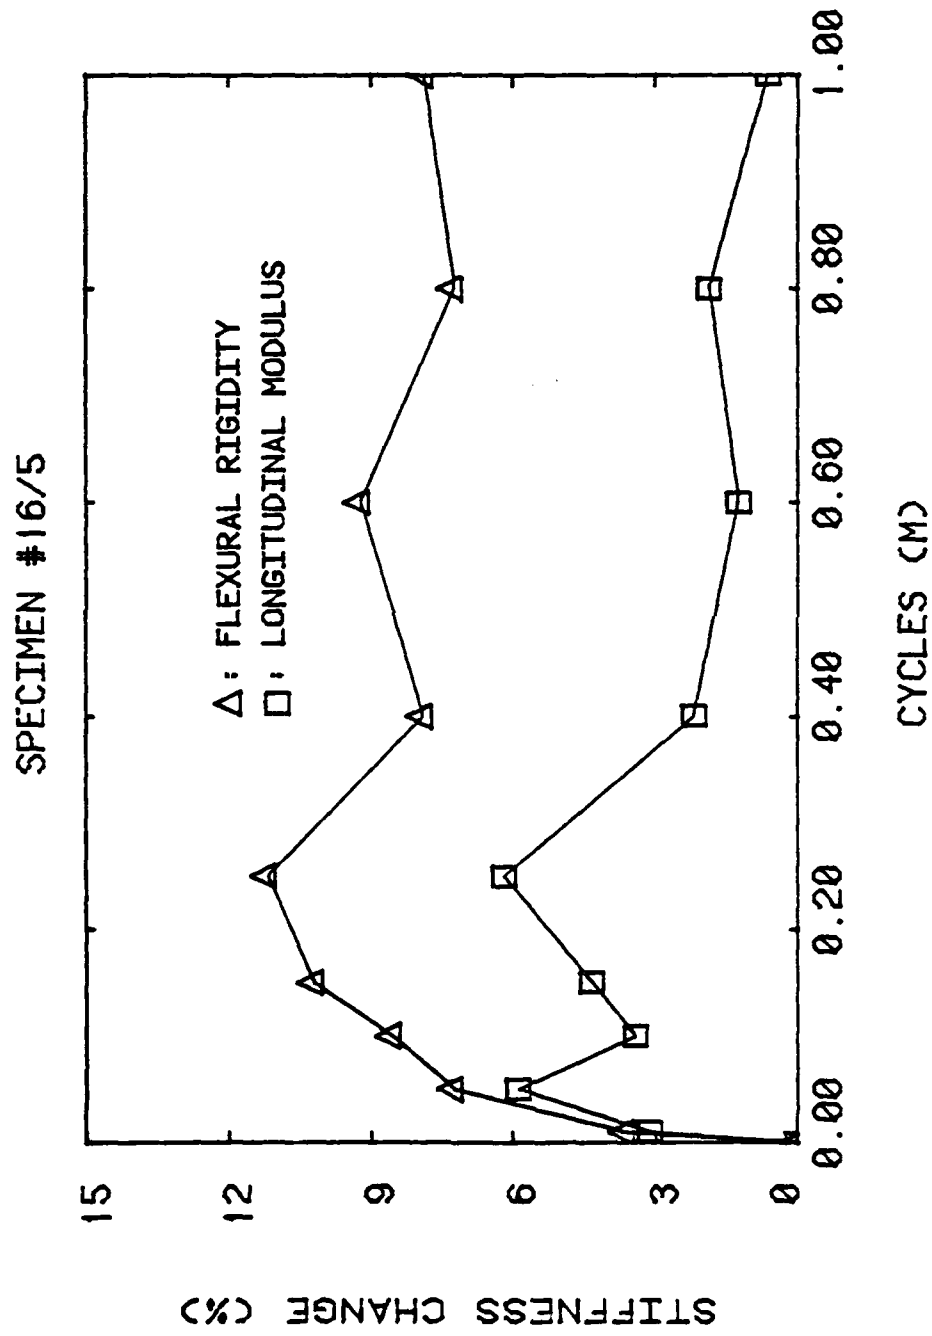
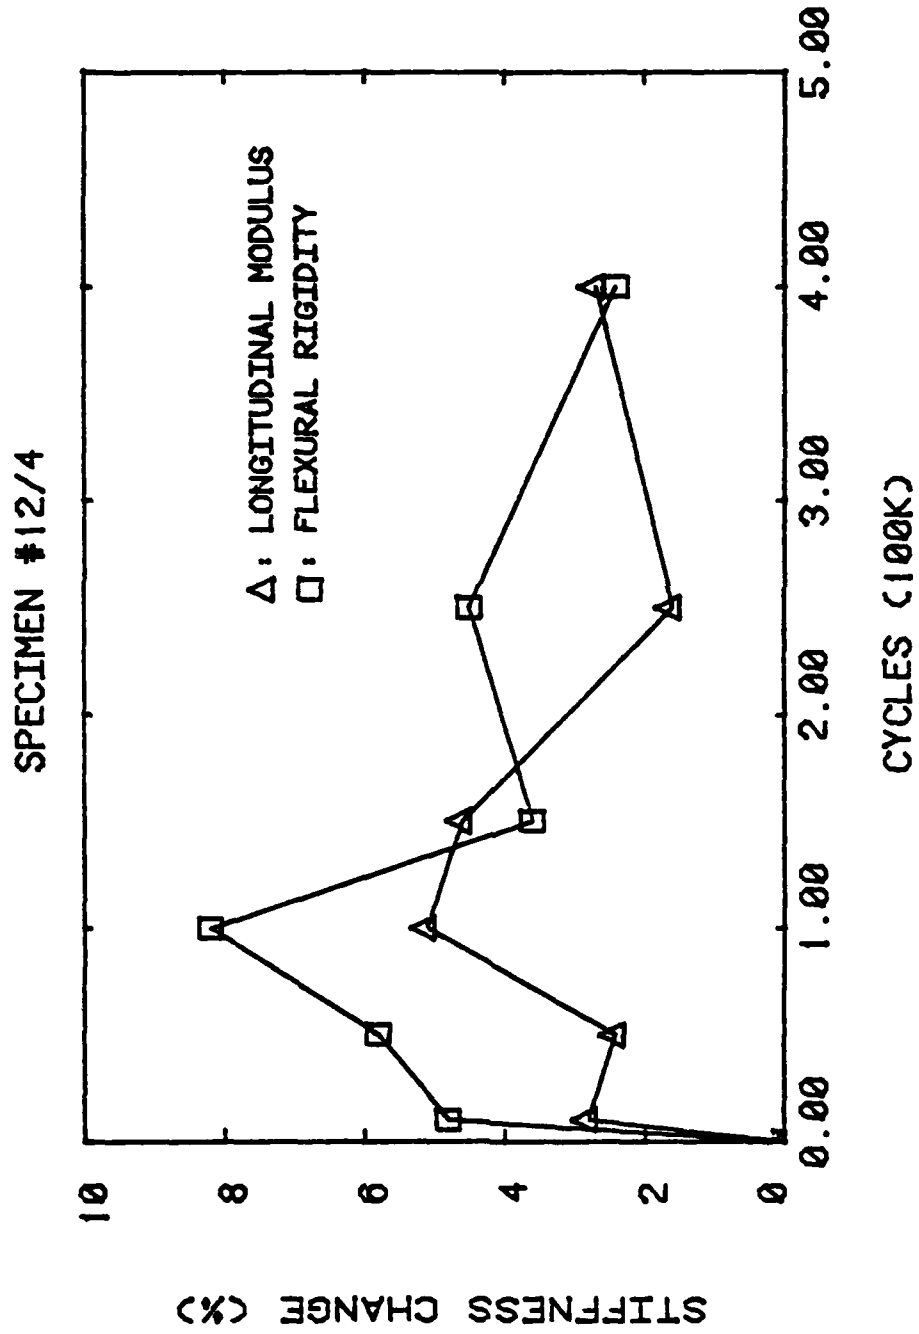
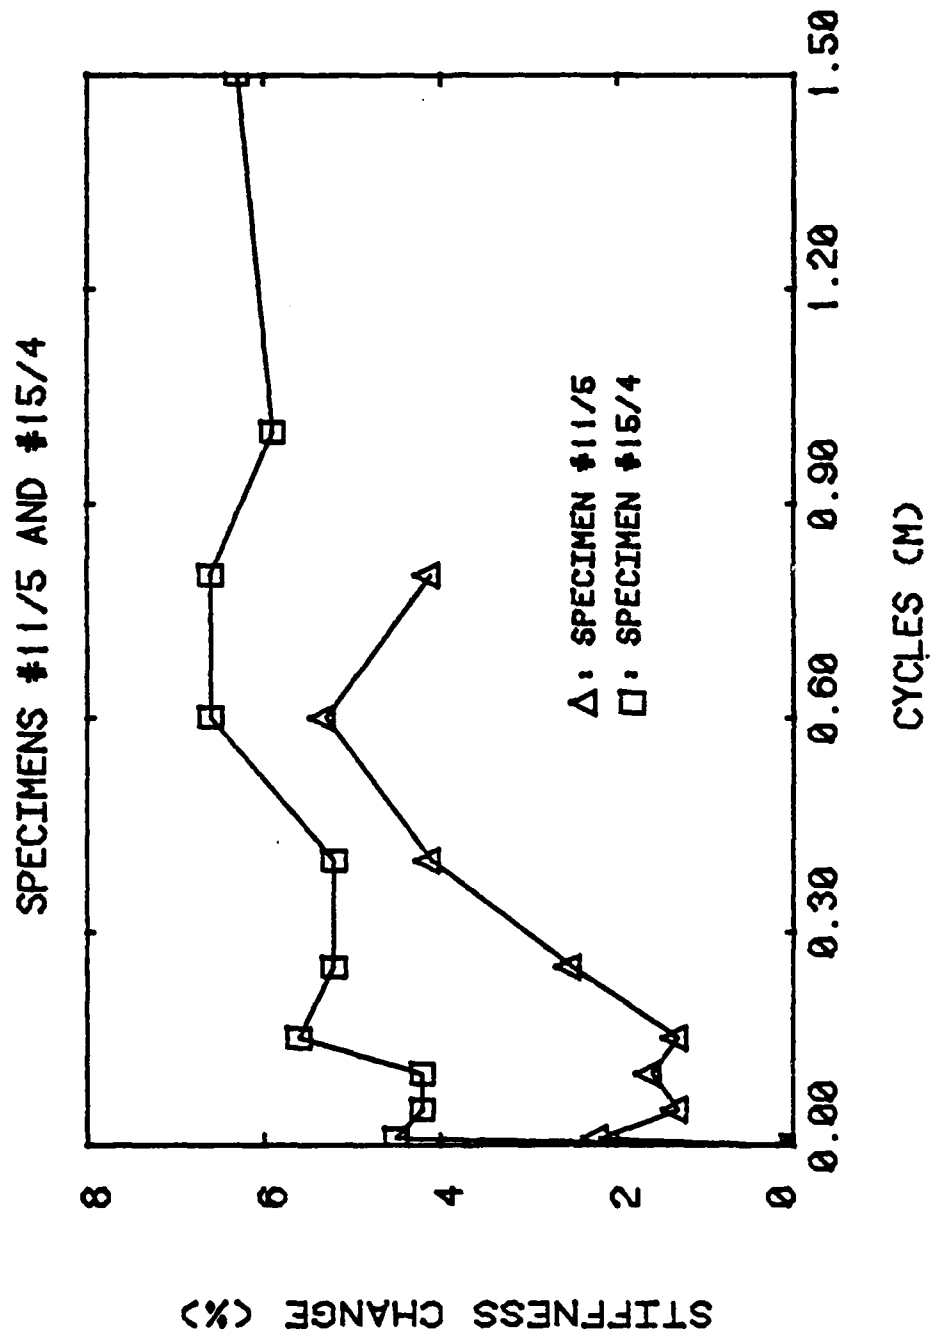
Figure 21: Stiffness Change versus Cycles of Loading in Bend Test

Figure 22: Stiffness Change versus Cycles of Loading in Bend Test.

Figure 23: Stiffness Change versus Cycles of Loading in Bend Test

Specimens 11/5 and 15/4 were tested monitoring only flexural rigidity. The results obtained are given in Table 9. The percent stiffness changes are plotted in Figures 23 and 24. Again, after 10K cycles both specimens showed large stiffness increases. However, the stiffness of specimen 11/5 (Figure 23) appeared to be stabilized before additional work hardening occurred. Just before failure at 810K cycles, a small additional stiffness change was measured. This stiffness reduction could indicate damage initiation or propagation. In specimen 15/4 (Figure 24) no significant stiffness change occurred after 150K cycles. When a residual strength test was performed after 1500K cycles,

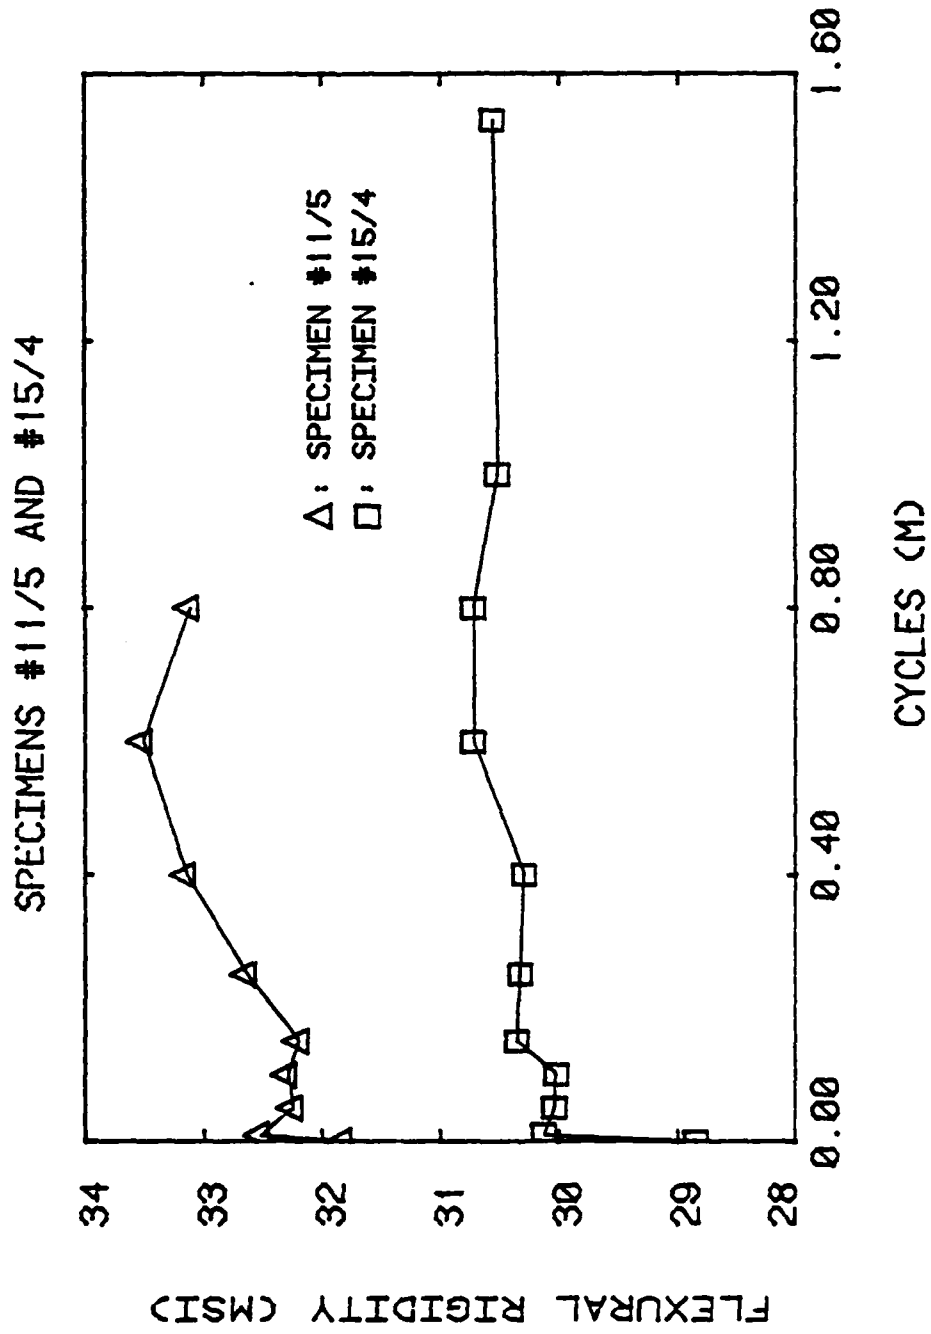
Figure 24: Flexural Rigidity versus Cycles of Loading in Bend Test

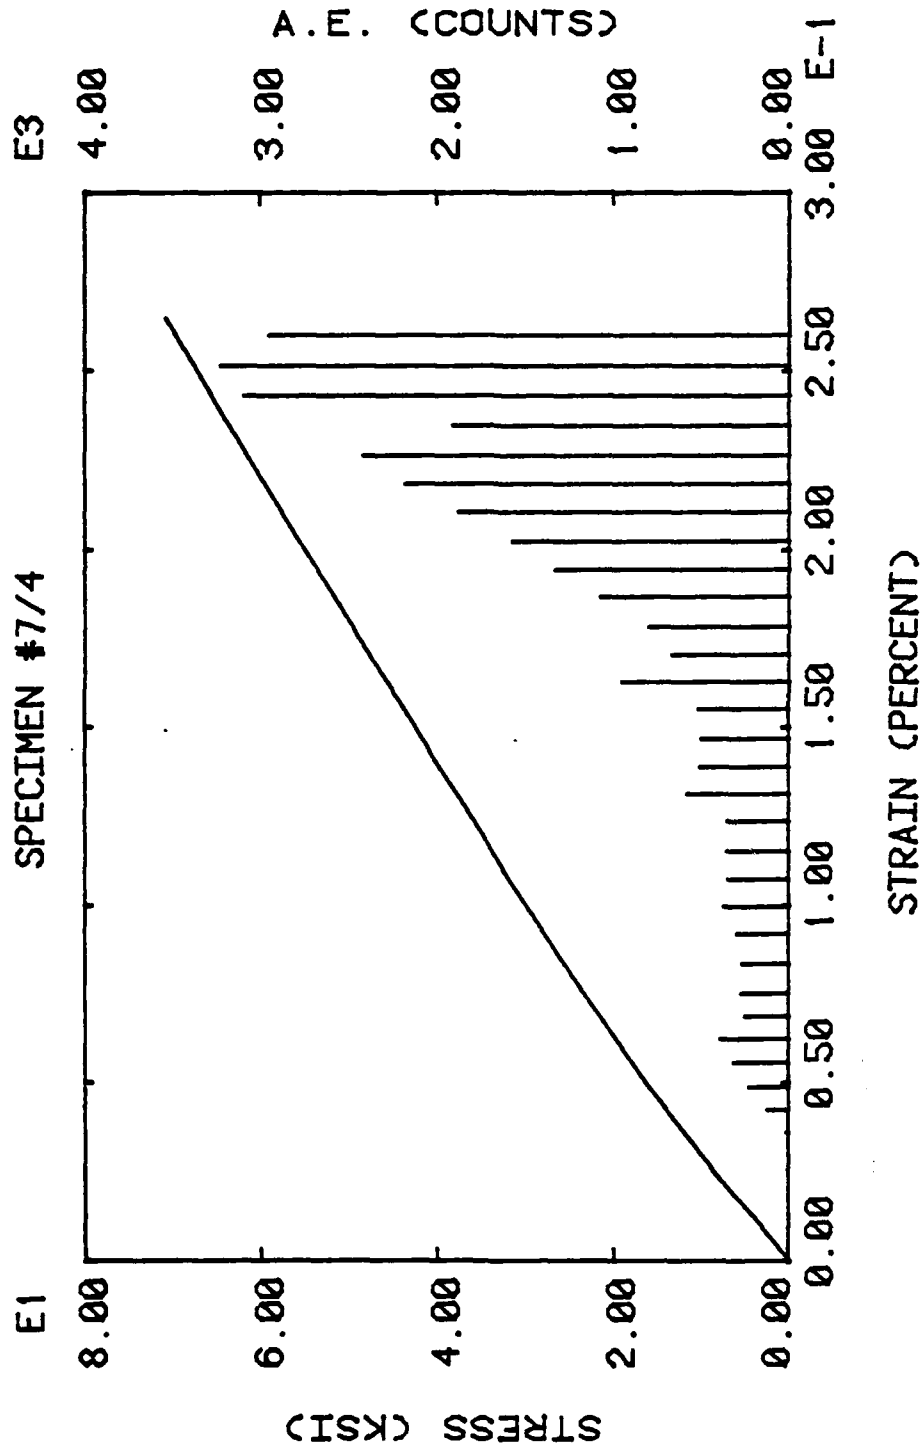
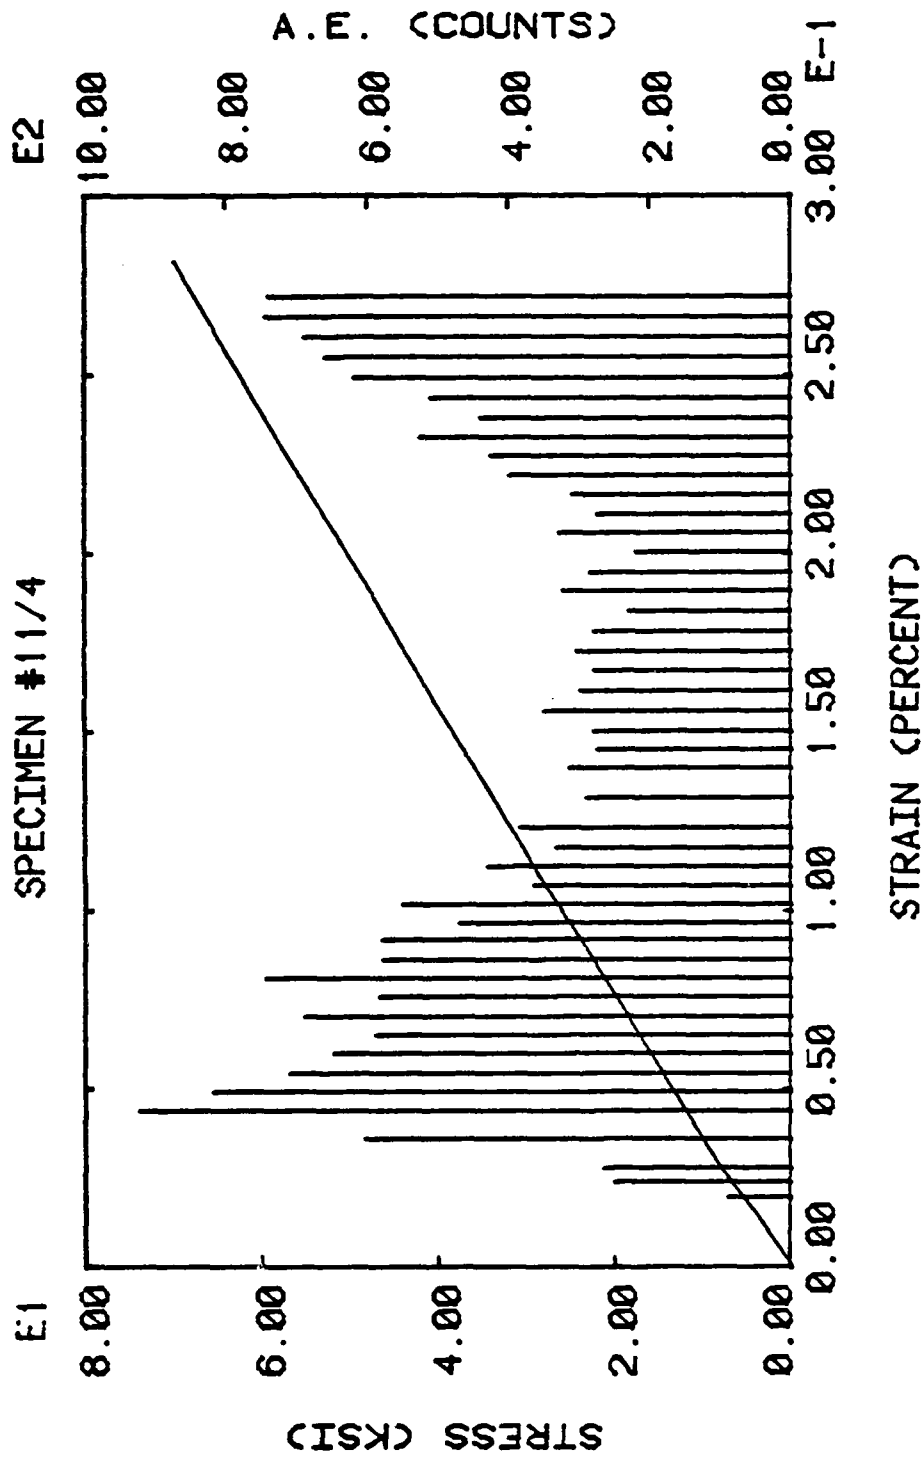
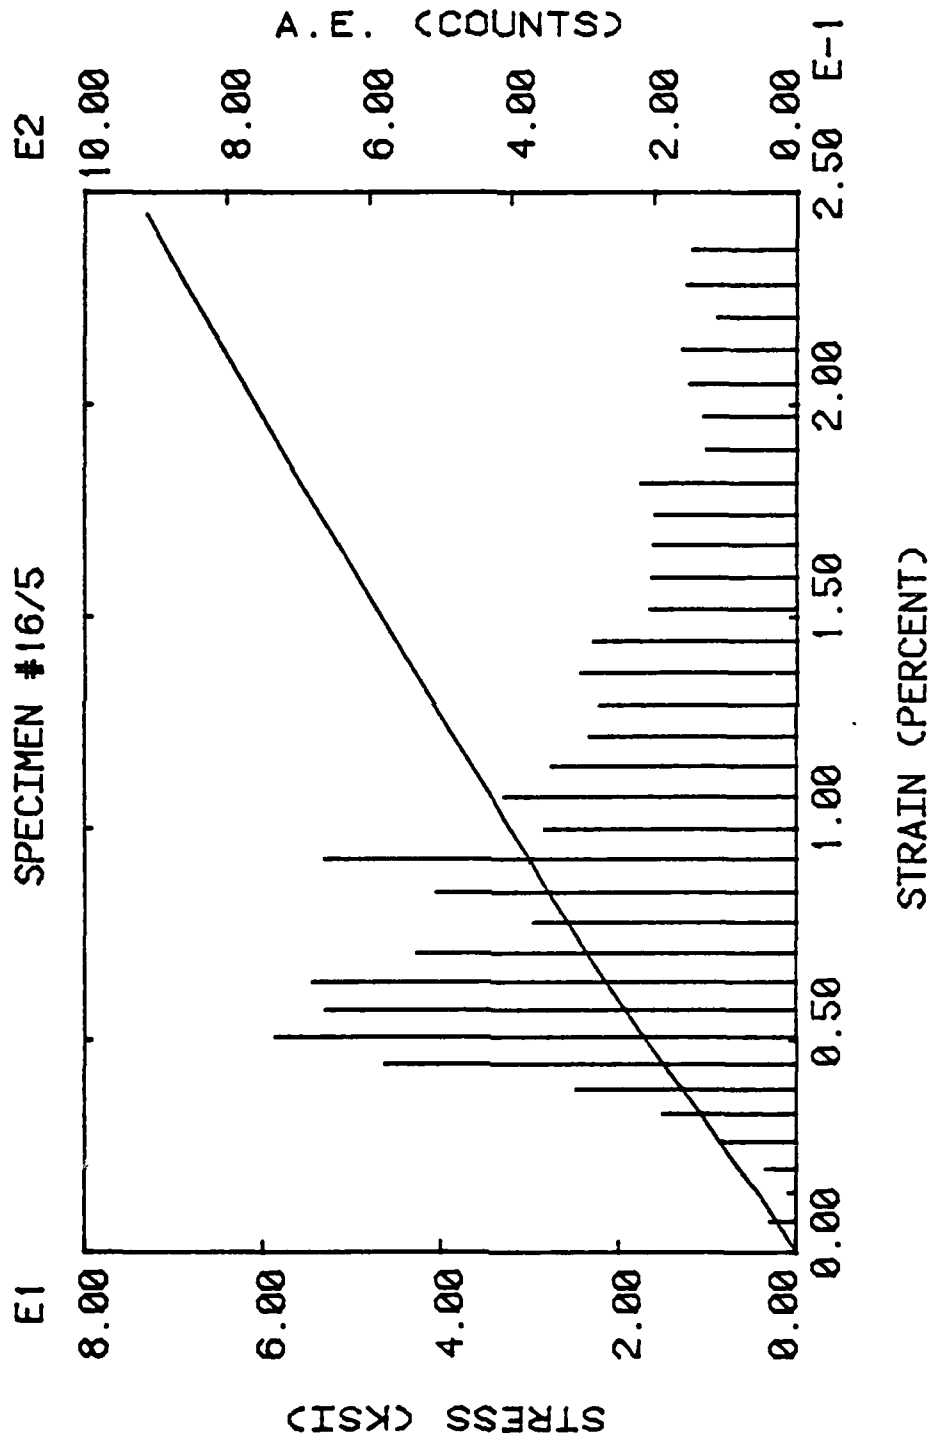
Figure 28: Stress and Acoustic Emission versus Strain for Axial Load.

Figure 29: Stress and Acoustic Emission versus Strain for Axial Load.

Figure 30: Stress and Acoustic Emission versus Strain for Axial Load.

Figures 28, 29 and 30 show typical acoustic emission behavior obtained during initial quasi-static axial tests for loads to 70 ksi. Notice that in general the emissions are concentrated in two load regions, one centered about 0.05% strain and the other centered about 0.25% strain. However, in Figure 28 (specimen 7/4) the initial AE concentration that appears in Figures 29 and 30 does not exist, even though the acoustic emission did initiate in this region. As the strain exceeded 0.15% the number of counts increased with strain until the maximum desired stress, 70 ksi, was obtained. For specimen 16/5 (Figure

30) this later increase in AE did not occur. However, it is important to note, that for other 55% V_f specimens this type of behavior was observed. There was no discernable reason for the lack of AE concentration in one or the other regions for a particular specimen, but this behavior was consistent with the bend test results discussed next.

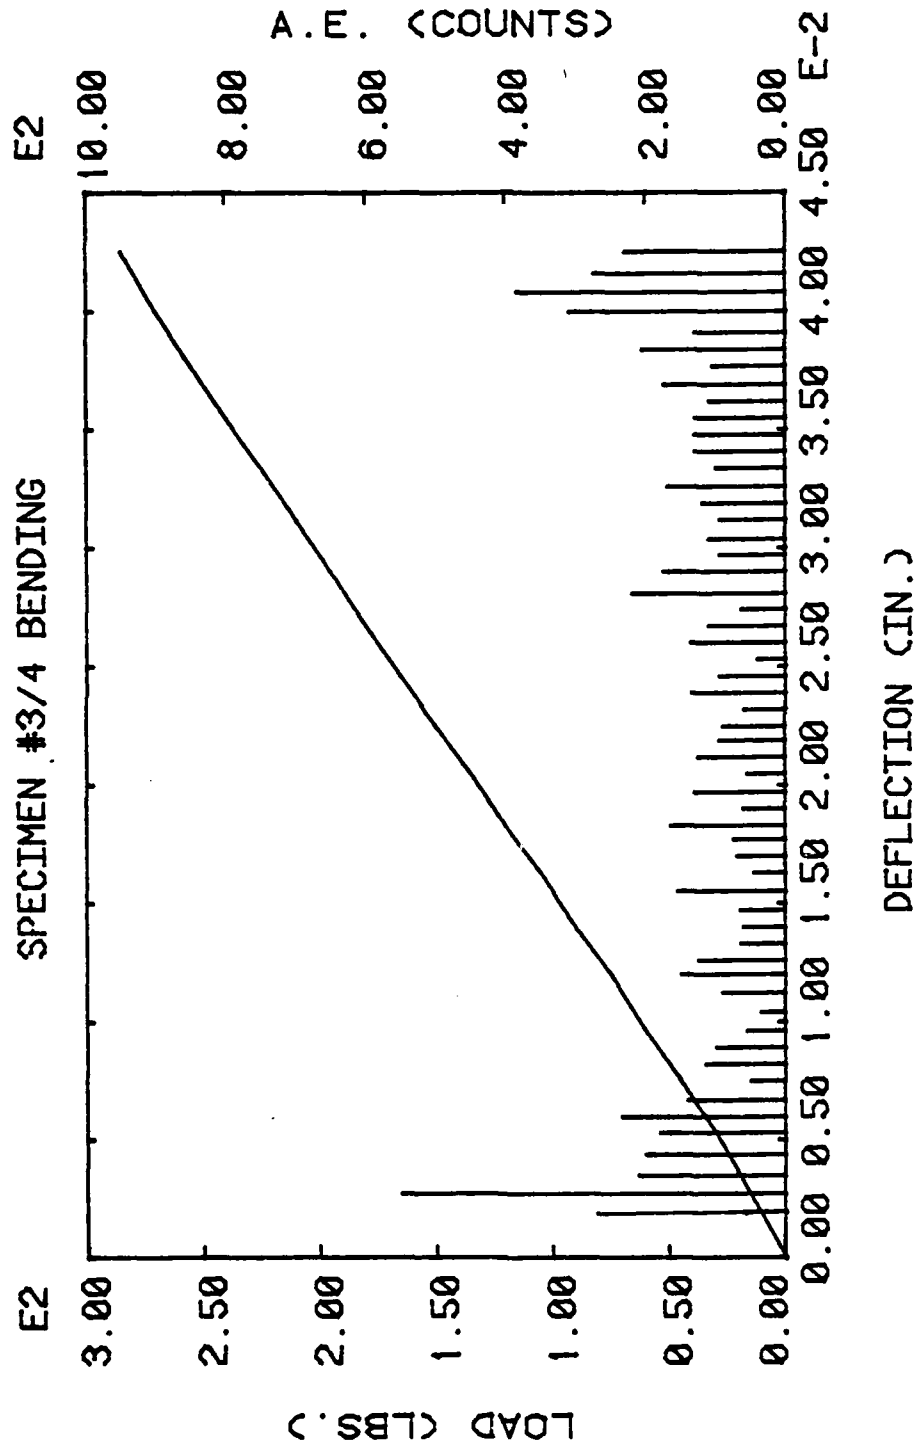
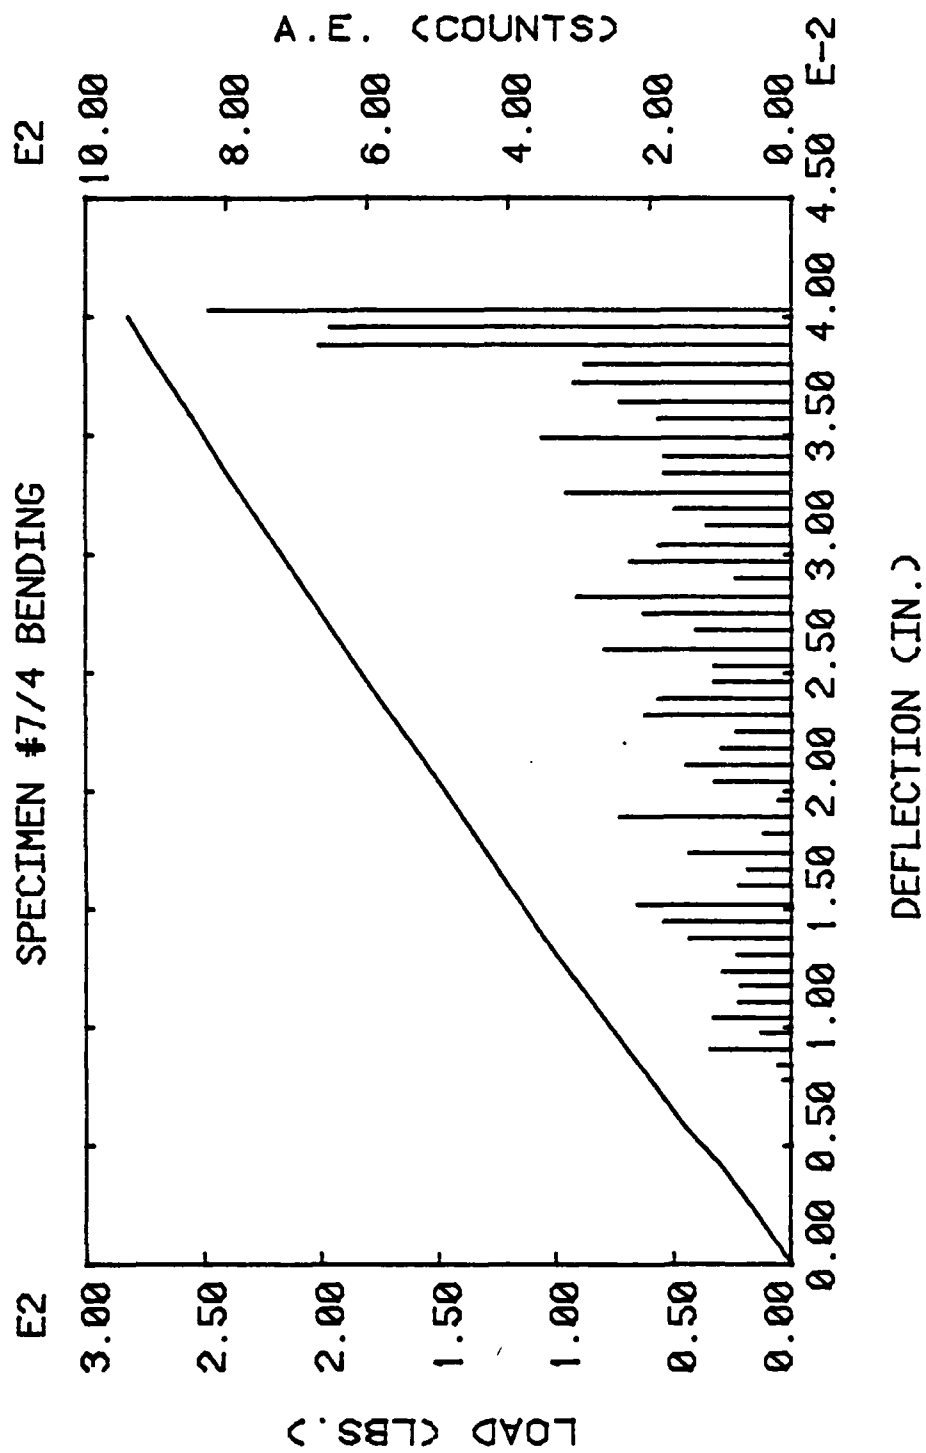
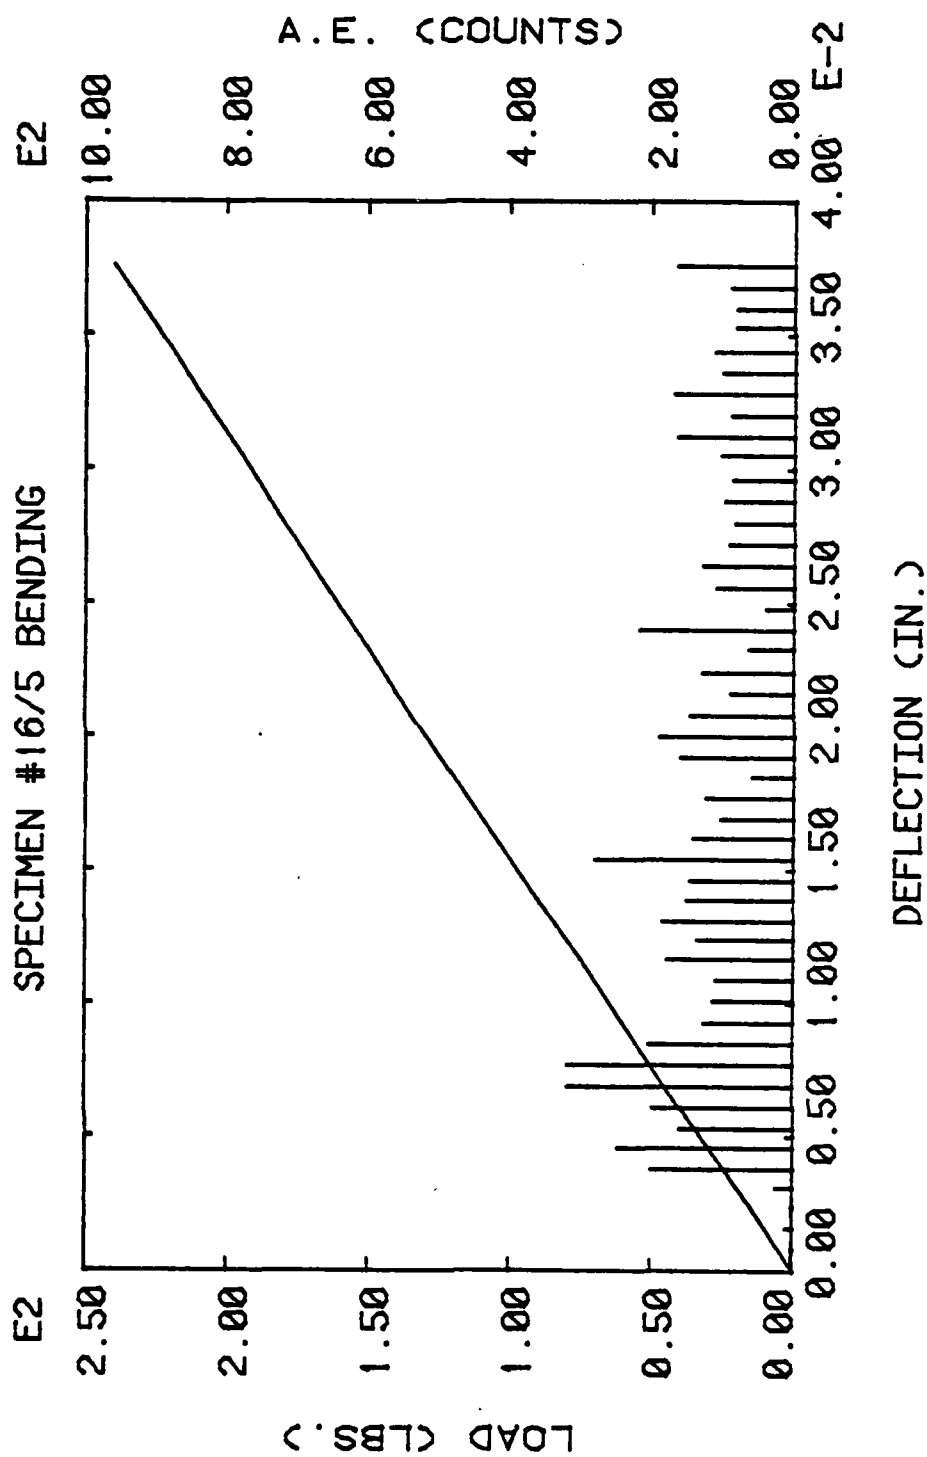
Figure 31: Load and Acoustic Emission versus Transverse Deflection for Flexural Load.

Figure 32: Load and Acoustic Emission versus Transverse Deflection for Flexural Load.

Figure 33: Load and Acoustic Emission versus Transverse Deflection for Flexural Load.

When comparing axial to bending AE, note that, in bending, after the outer fibers yield, the plastic zone moves inward toward the neutral axis. This explains the relatively constant emissions that occur. The AE increase that occurred in most tests at high loads is believed to have been caused by material damage. Specimen 16/5, for which low level AE occurred at the higher loads, did not fail until after enduring over one million fatigue cycles. This suggests that a "strong"
